PMP Autumn Newsletter 2014

Typhoon Crash!

The Fuselage Repair

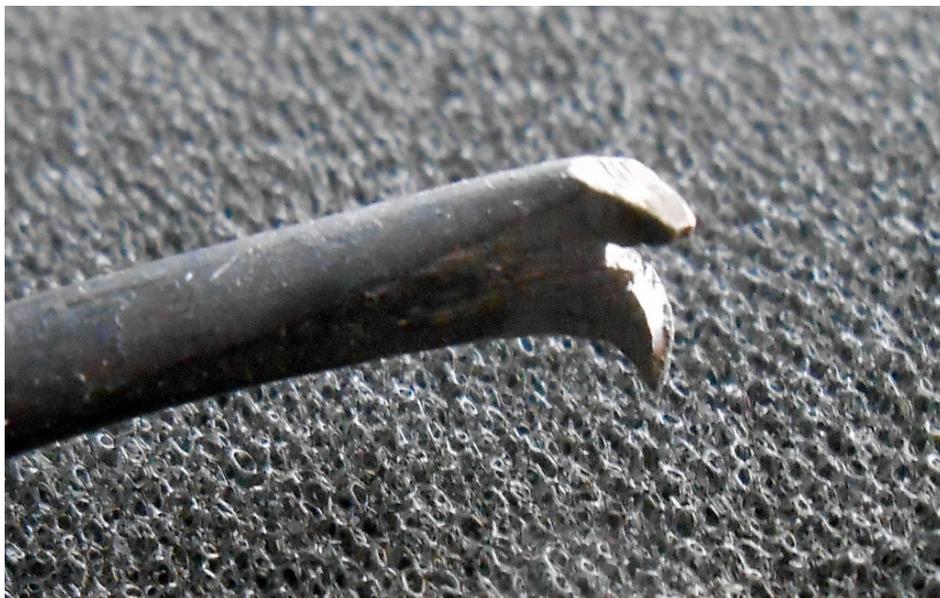
Clevis Tool

After several failed attempts to re-attach the elevator pushrod I came up the idea of bending the tip of a very long screwdriver at right angles, inserting it in the clevis and rotating it 90 degrees to open the legs of the clevis so that they would slide over the tail crank. When the clevis was in position remove the 'tool'! Easy. Practice was not quite so simple as I first had to make the long screwdriver by flattening the end of a piece 8swg piano wire and bending the end over. To do this I had to use a blow torch to soften the carbon steel piano wire both to flatten the end and bend it to 90 deg without breaking. Visibility was a bit of a problem but fortunately I had one of those LED penlights you can buy in most markets for a £1.00. This I inserted into the broken end of fuz along with the elevator pushrod. I taped the tailcrank in place to stop it moving and then gingerly attempted to slide the metal clevis in position. On the second or third attempt I succeeded. Hooray. Now to repairing the fuselage.

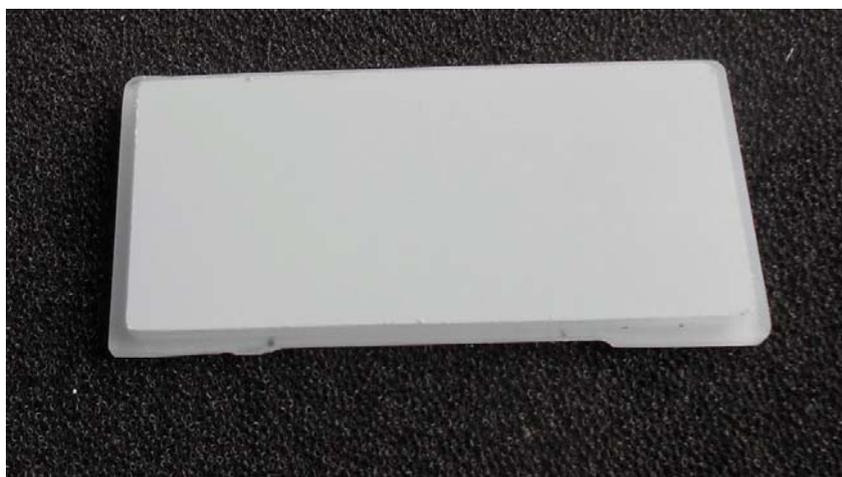
Graupner MC32 Screens

Following on from our last newsletter, re the Graupner MC32 LCD screen covers, it has been suggested that the problem was the plastic used had not been UV stabilised causing it to go translucent when exposed to a hefty dose of sunlight. I have tried for several months to get replacements without success so having a router handy decided to make the replacements myself using UV stabilised clear acrylic. The originals were injection moulded but of simple design apart from the back of the small screen which was recessed. Any way it made no difference and we have one happy MC32 customer. So if anyone with difficulty to read MC32 screens and need to change them I made a few extra.

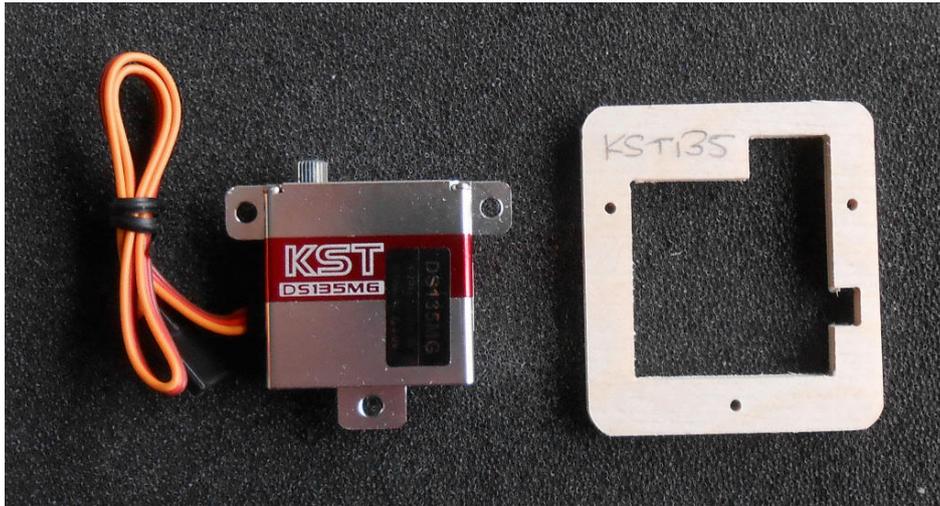
KST 135MG Servo

If you looking to fit out your mouldie with some better quality servos at a reasonable price then take a look at the KST range, particularly the KST135/145MG, same servo different lug fixings. Generally you only get what you pay for when goods pass through the normal retail supply chain i.e. manufacturer, export agent, importer / distributor and retailer. All take their cut. With KST, we buy direct from the manufacturer and as a result are able to sell them at a very competitive price and yet maintain a margin to support after sales service which fortunately to date has been almost non existent. All my mouldies (3) are fitted with KST servos, they transformed the Typhoon.
